Natural Propagation and Habitat Improvement

Volume II - Idaho

Final and Annual Reports, 1984

Lolo Creek Habitat Improvement

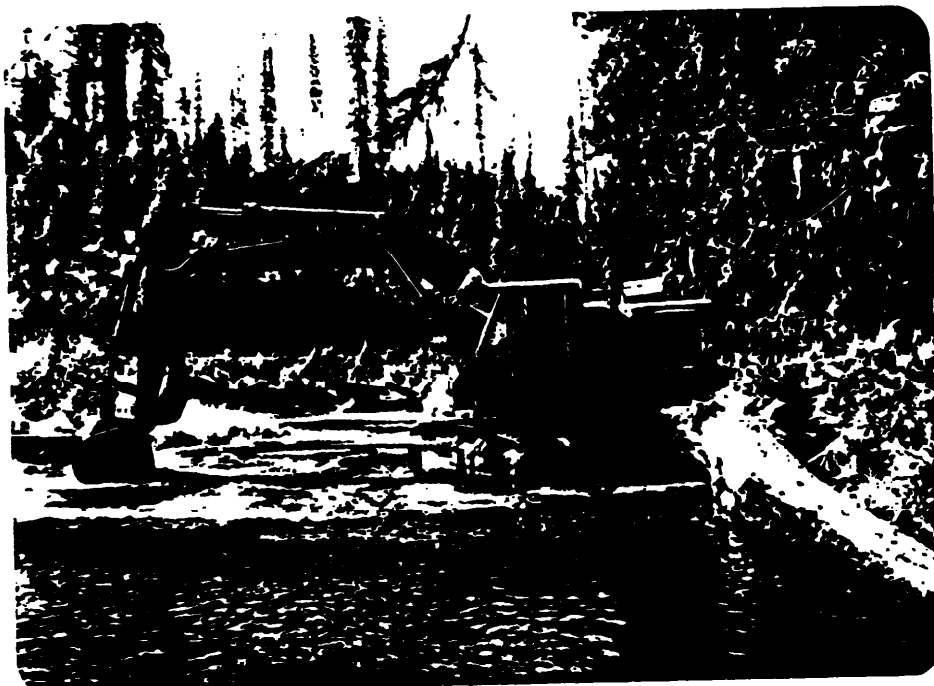
<u>Structure Types</u>	<u># Needing Maintenance</u>	<u>Cost of Maintaining Each Structure</u>	<u>Conditions Requiring Maintenance</u>
K-dams	5	\$250	Gravel washed out of wing cribs.
	2	\$30	Wire settled in at log-wire junction.
Log Weirs	11	\$100	Wire peeled back toward log from upstream end (Figure 3).
	3	\$250	Bank erosion. Water washing around the end of the log.
	1	\$500	Complete displacement of structure from site.
	5	\$50	Wire settling on upstream side of the log.
	1	\$250	Large debris catching on log and deflecting flows into bank (Figure 4).
		\$50	Beaver constructing dams on structures.

Figures 3 and 4. Upper photo shows typical maintenance problem of wire peel. Lower photo shows crawler backhoe resealing log weir.

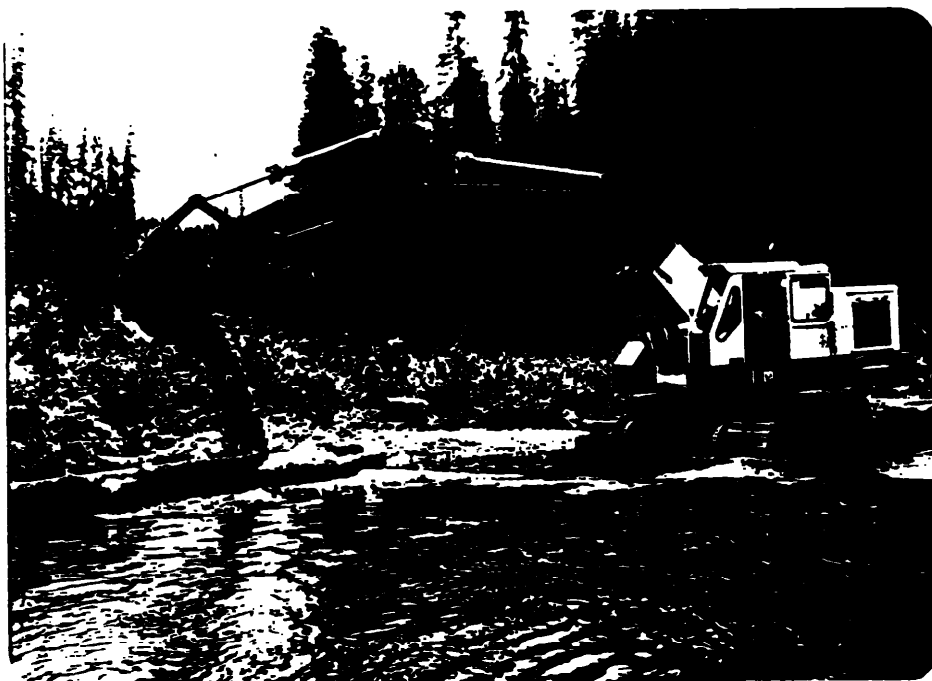
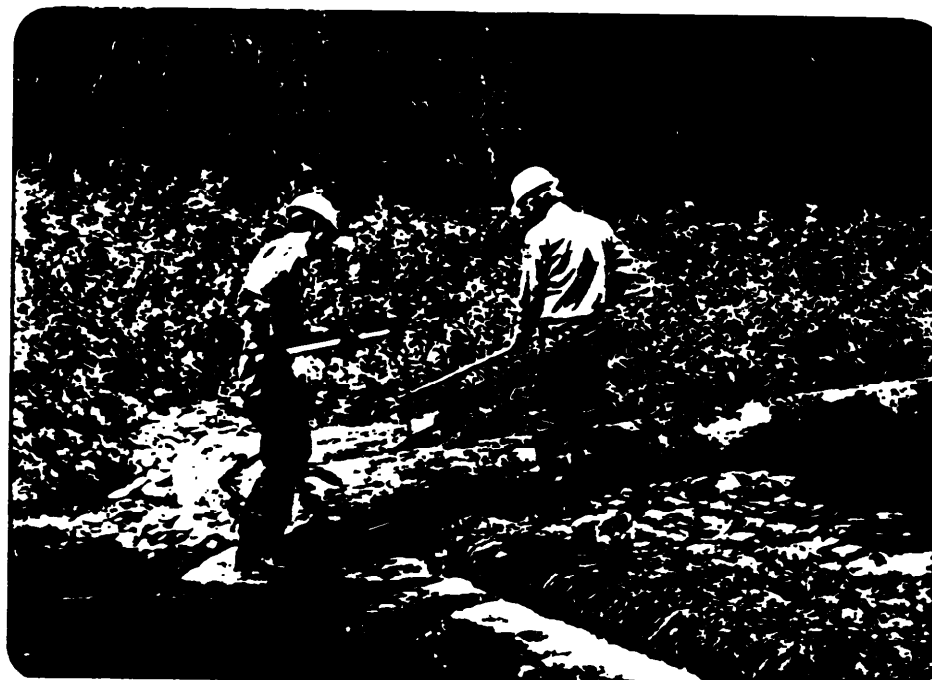
Figures 5 and 6. Upper photo shows backhoe filling in "high water wing" added to existing log weir. Lower photo shows crew pinning "high water wing" to log weir.

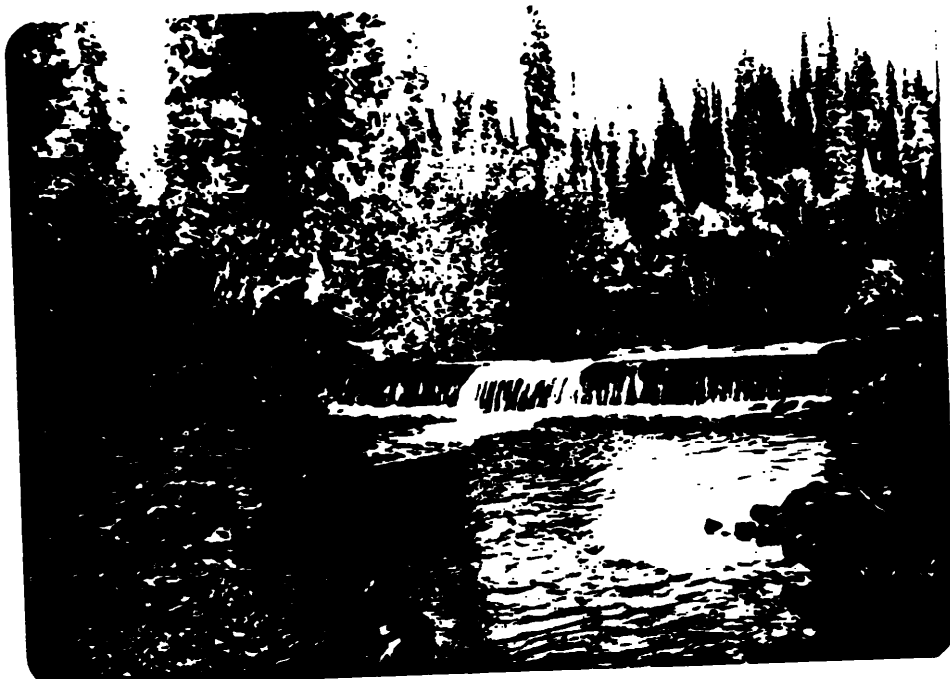
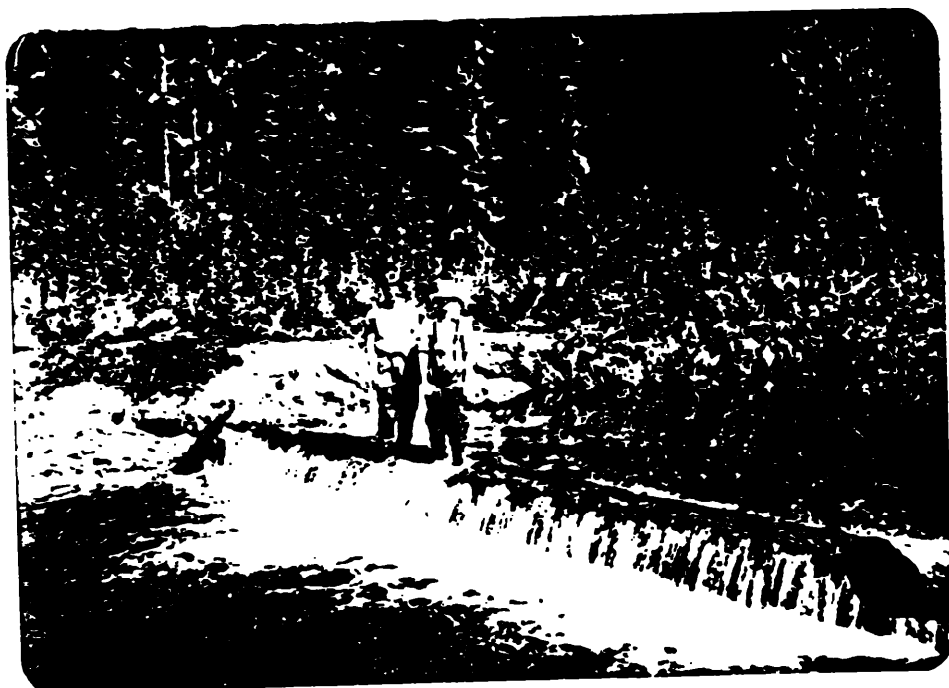
described in the 1983 Annual Report (pages 34-60). The exception is the improvements we have made in the design and construction of K-dams. These improvements are designed to increase the longevity and eliminate costly maintenance. Appendix D, Figures 18 and 19 show the improvements in design made to eliminate the loss of rip-rap from the downstream cribs.

Figures 18 and 19. Upper and lower photo show completed K-dams and modified wing supports.

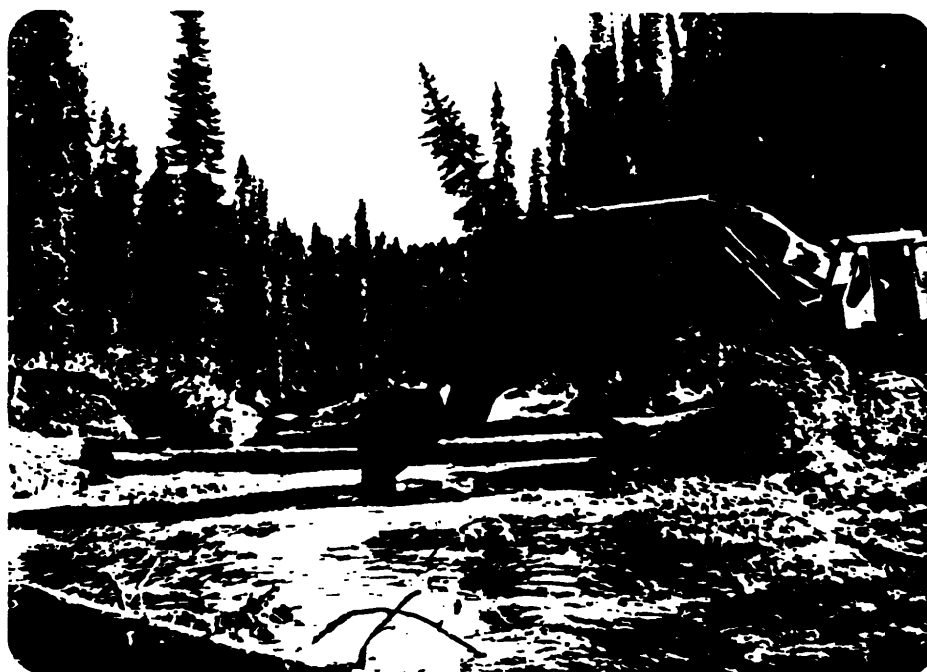
Figures 22 and 23. Upper and lower photos show backhoe filling in main log weir.

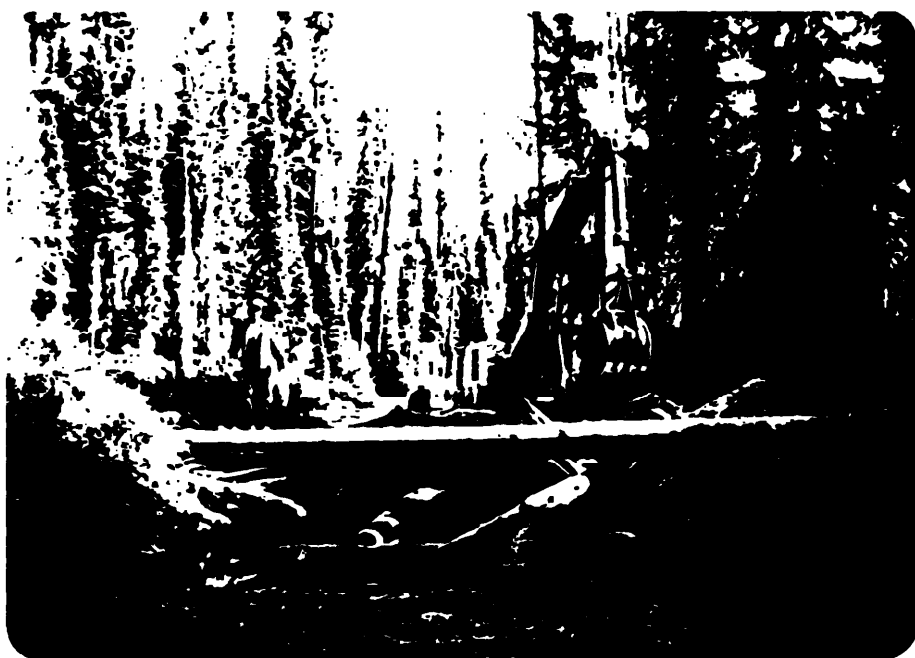
Two large debris jams causing excessive ponding and tremendous sediment deposition were removed with the crawler backhoe. The braided side channels created by these jams were preserved as well as their water supply. Figures 51 through 55 show the activities associated with removing these jams.

Figures 51 and 52. Upper and lower photos show the 2 debris jams removed in 1984.

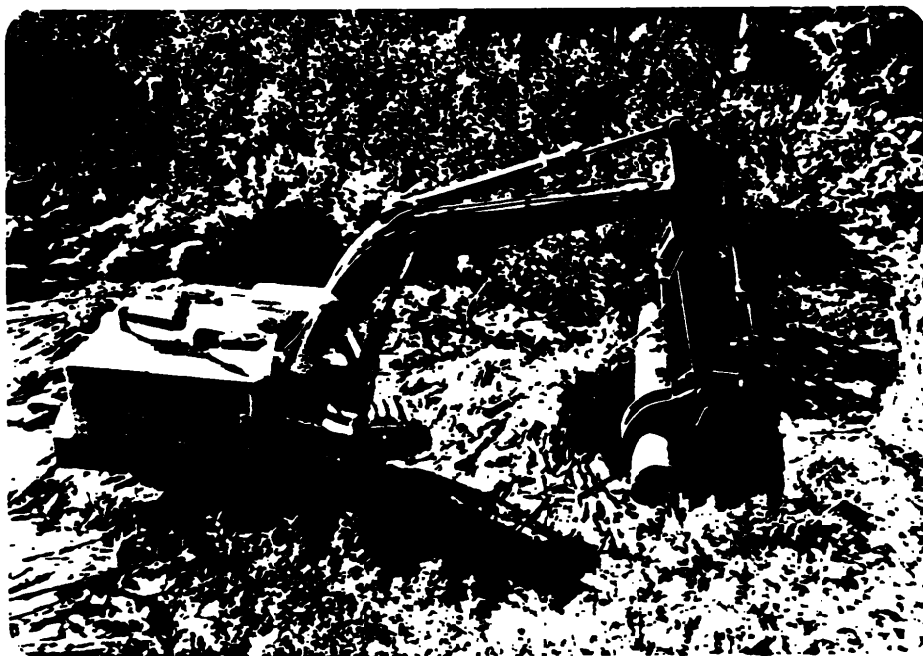
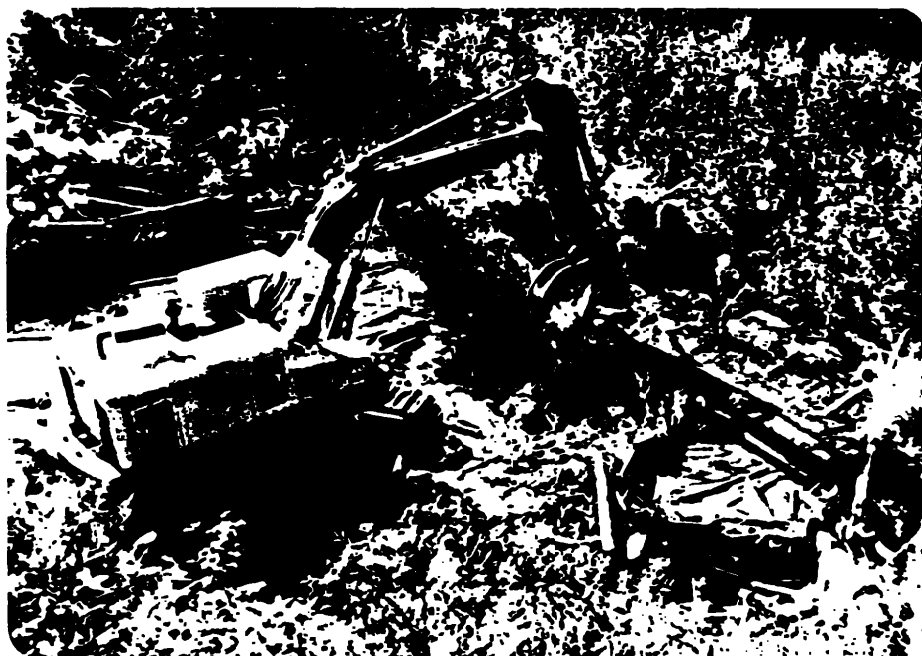
Figures 53 and 54. Upper and lower photos shows the backhoe working on the debris jams.

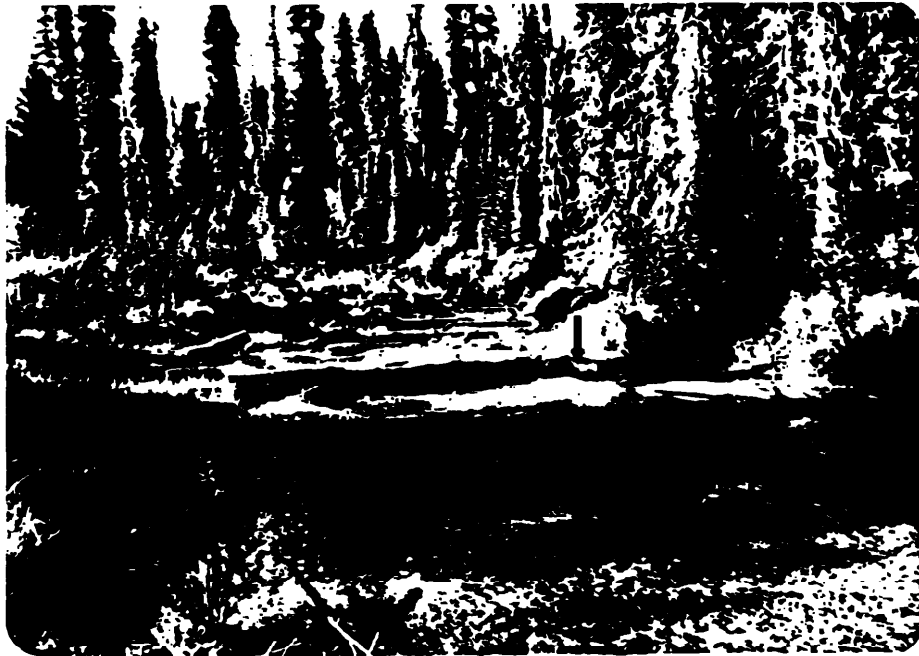
Figure 55. Photo shows site after jam removal. Note sand dunes upstream from site.

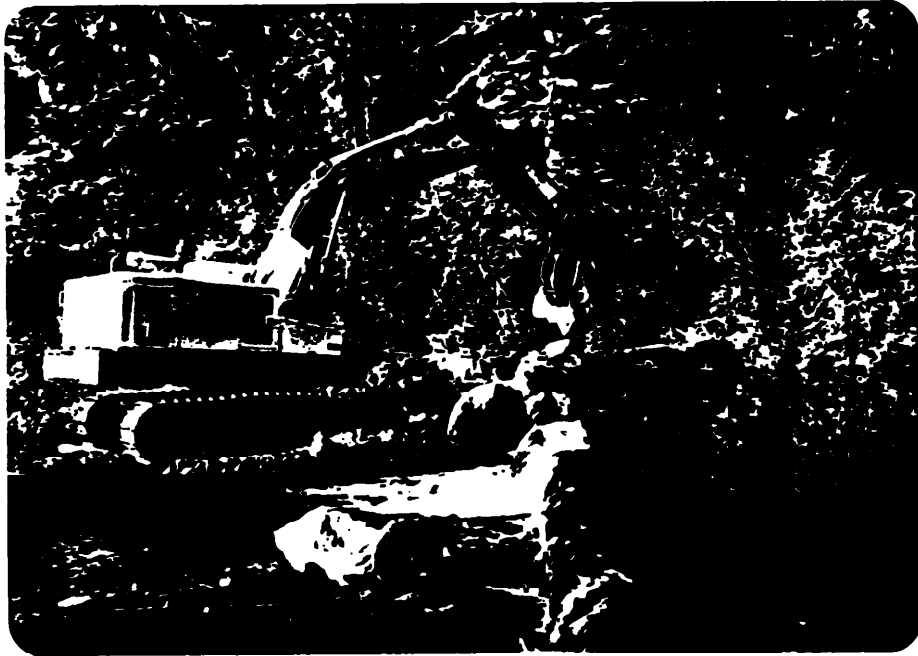
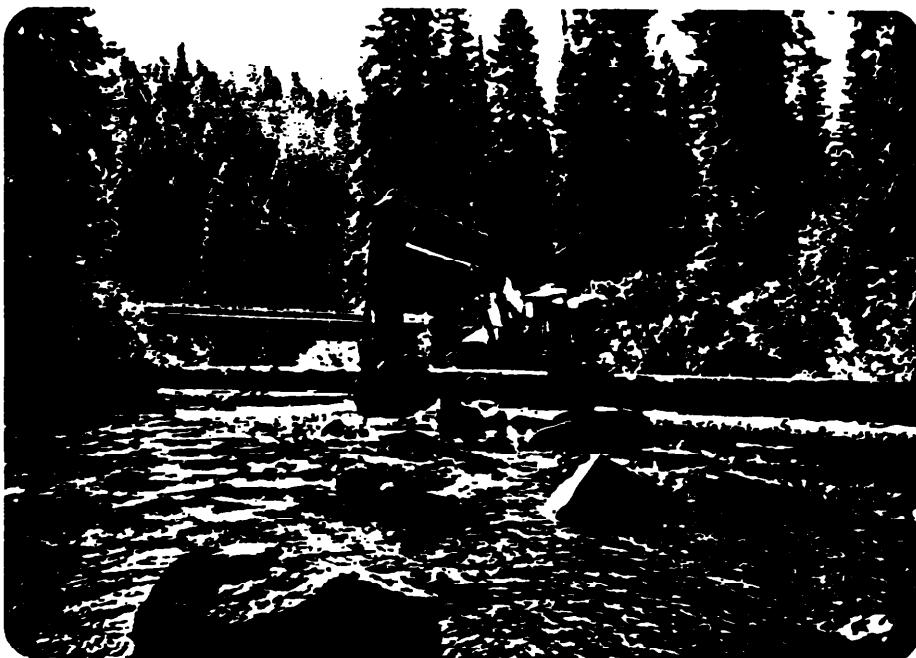
One very large K-dam was constructed (map #50, Appendix E). This log was a 42 inch DBH western white pine, spanning the channel 90 feet from wetted edge to wetted edge. The large size was necessary to withstand the force of high flows in this reach. Figures 56 through 59 illustrate this structure.

Figures 56 and 57. Upper and lower photos show backhoe working on large log weir.

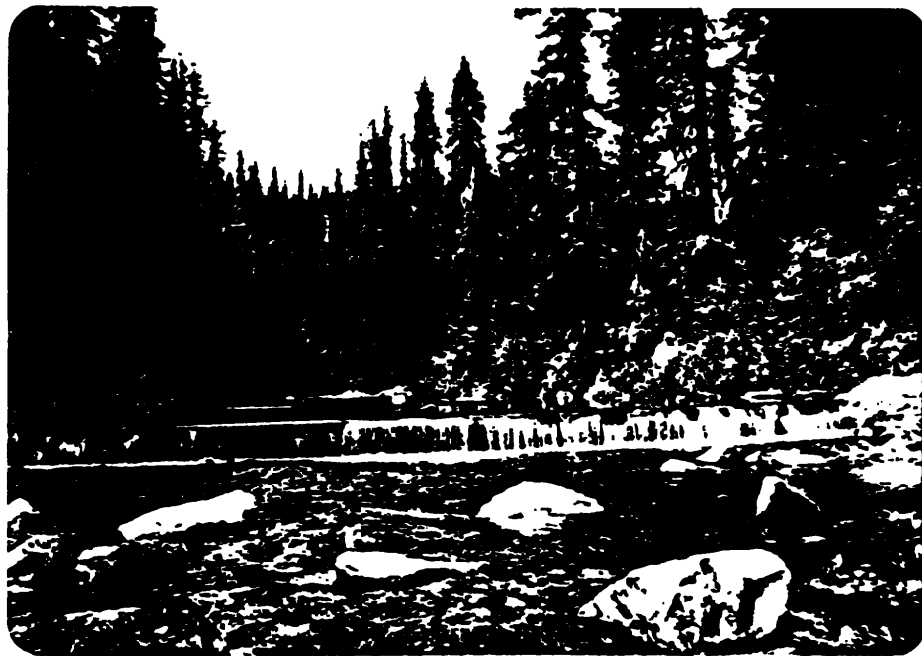
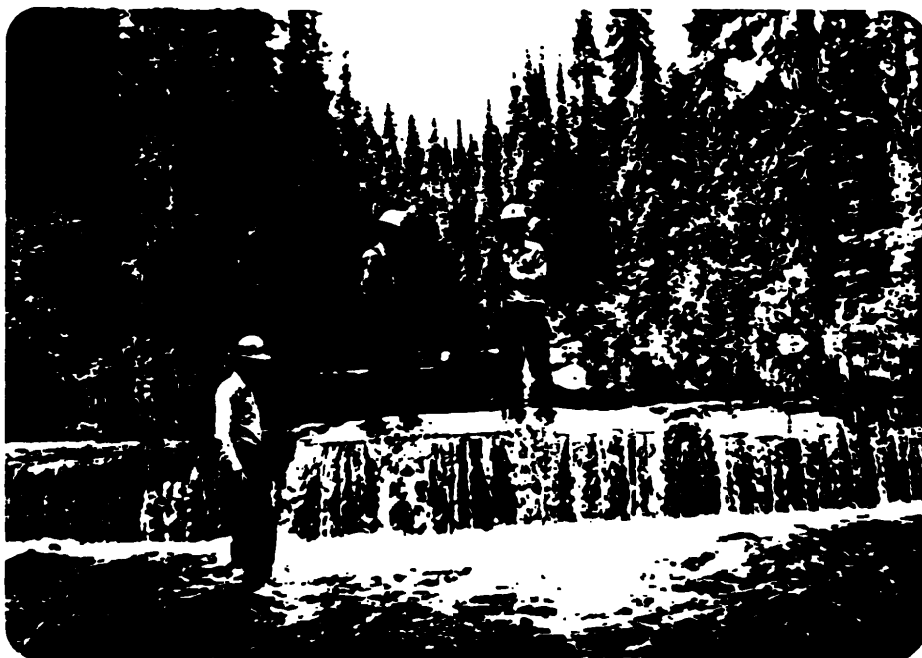
Figures 58 and 59. Upper and lower photos show completed weir.

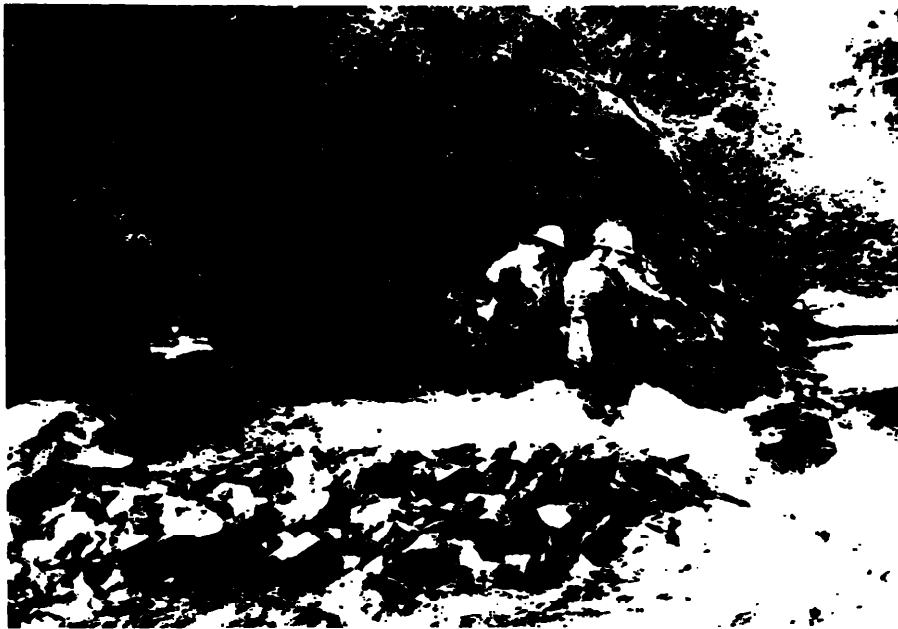
Figures 15 and 16: Upper and Lower photos show crew working at barrier #3, Eldorado Falls.

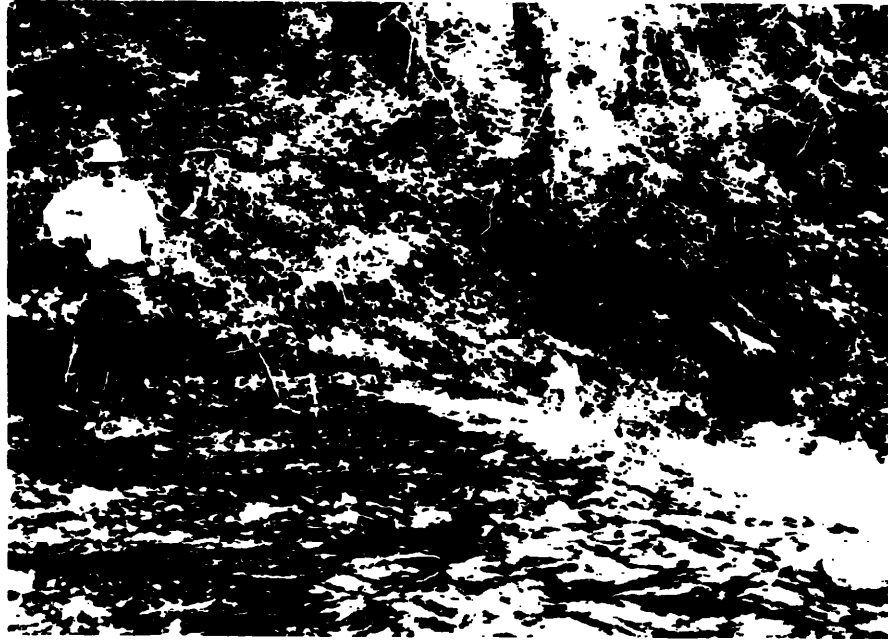
Figures 17 and 18: Upper photo shows blaster Bill Wells with holes drilled and primer cord in hand. Lower photo primer cord strung out with charges set.

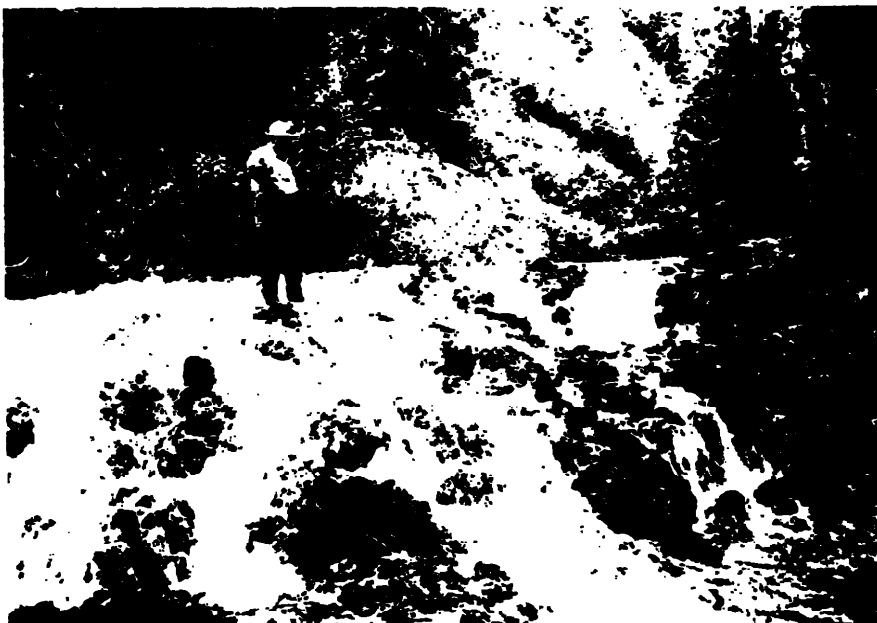
Figures 19 and 20: Upper photo shows crewman pitching basalt rocks from blasted pool. Lower photo shows Bill Wells and recently blasted pool at barrier #1.

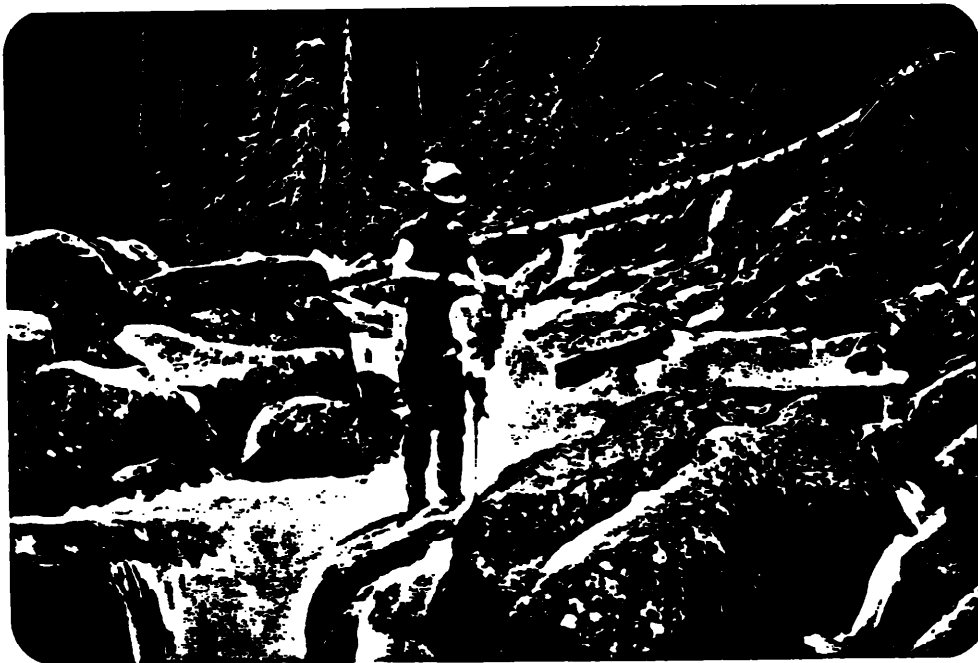
Figure 6. Drilling a hole for explosives using a Pionjar rock drill at Site No. 7A, Crooked Fork Creek, 1984.

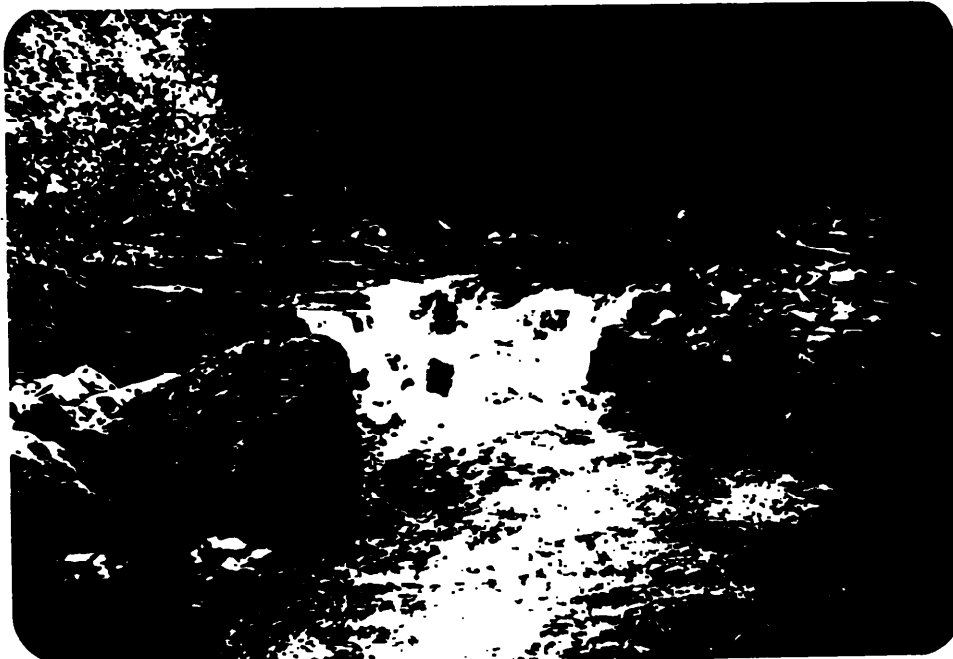
Figure 29. Pre-blasting view of barrier No. 6.

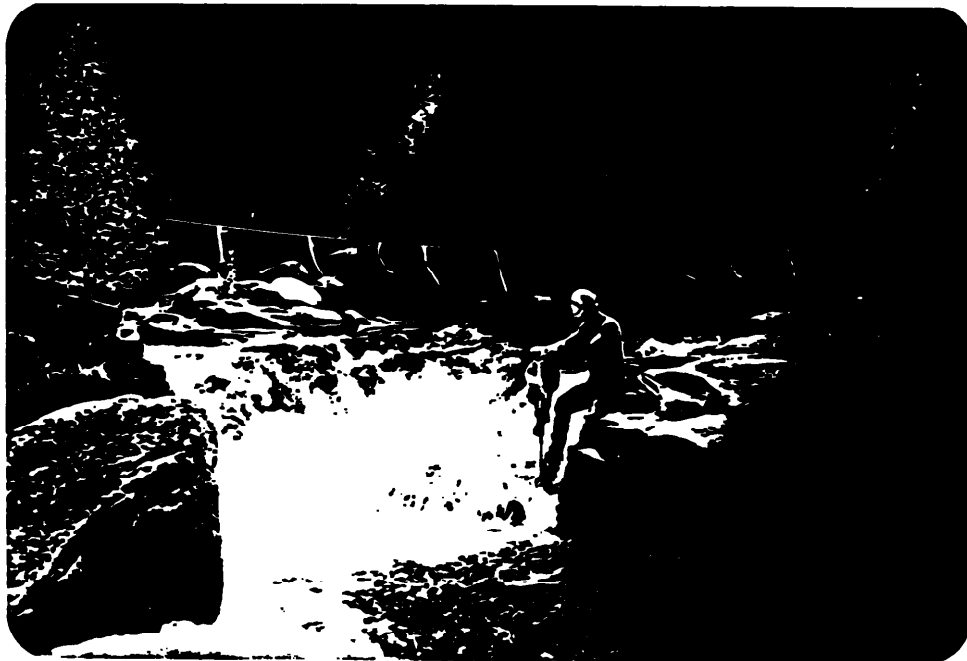
Figure 30. Post-blasting view of barrier No. 6.

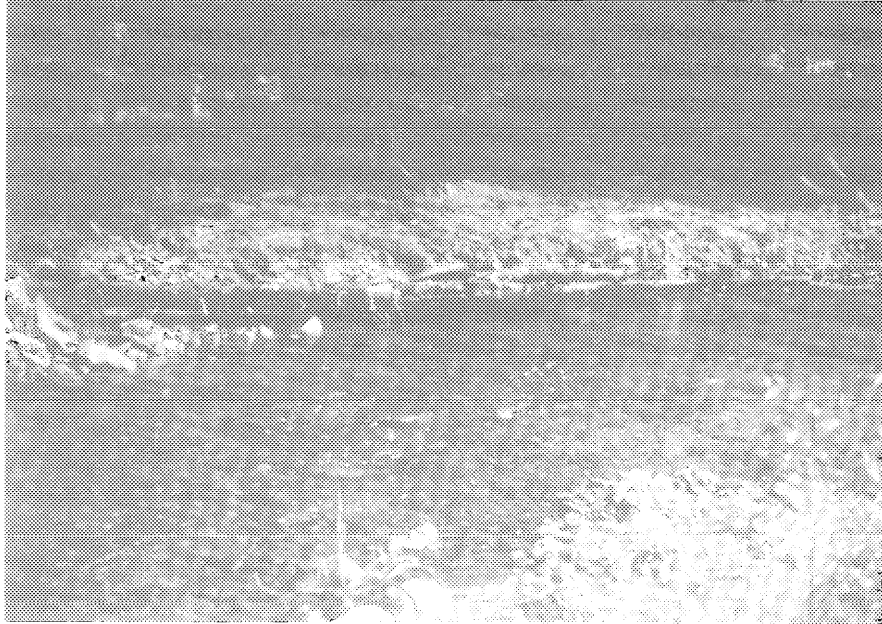
### Example I - Red River

Description - This was a 3'-5' vertical, eroding streambank, It was a constant, source of sediment which adversely affected otherwise good spawning and rearing habitat located in this stream reach, Due to its over--steepened nature it was not stabilizing and revegetating naturally.

Treatment - This site was treated by the crew using hand tools. Logs were placed at the toe of the slope and backfilled by hand with streambed rock, The bank was then cut back and shaped, seeded, fertilized, mulched and planted with willow cuttings,

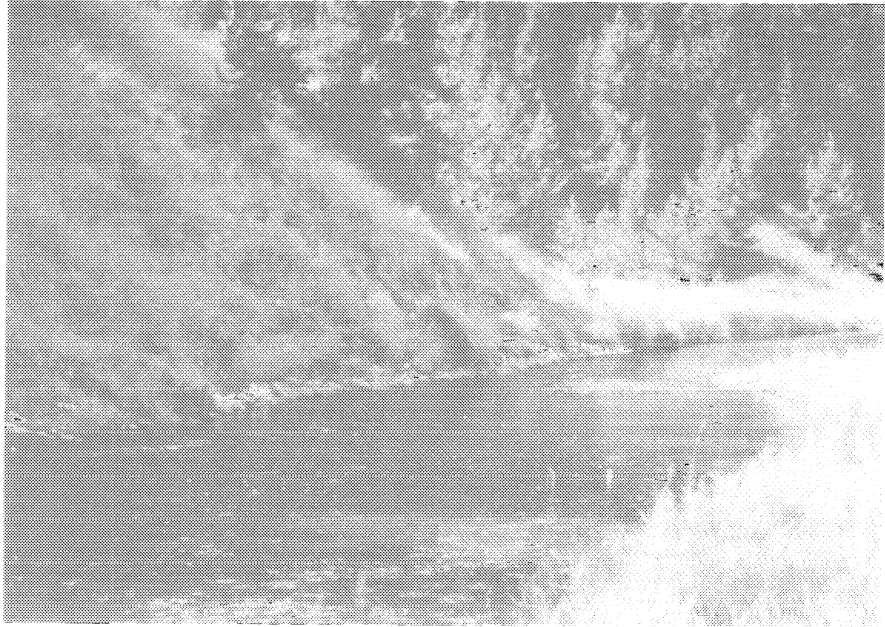
### Example 3 - Red River

Description - These are 10'-20' high banks of overburden material left after removal so the area could be dredged for gold. Erosion has been occurring at the toe of the slope; subsequently the upper slopes are experiencing mass wasting and sloughing into the stream.

Treatment - The toe of the slope was protected with logs held in place with fence posts. Logs were then back filled with rock and sod. Upper banks were seeded and planted with trees and shrubs.

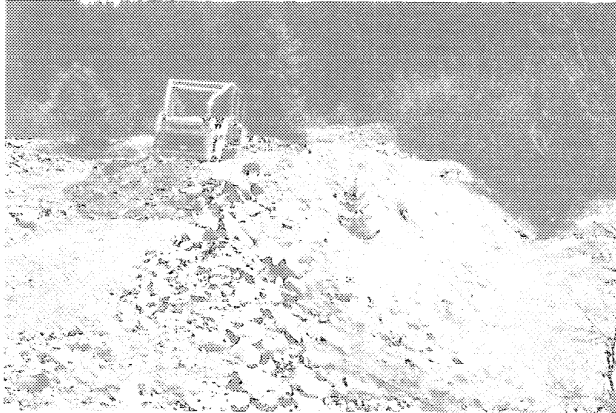
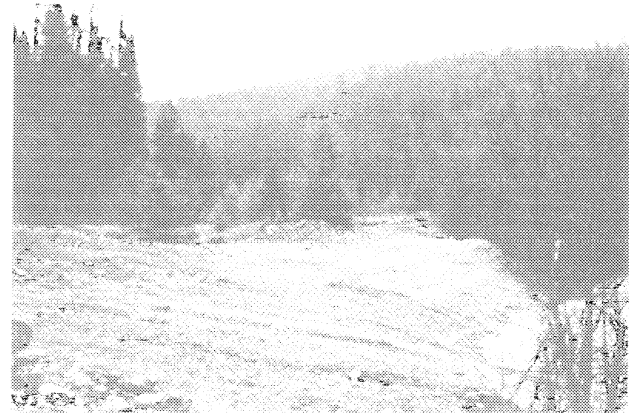
### Example 5 - Crooked River

Description - This is a section of dredge tailings remaining along the stream after dredging for gold. These were unstable and eroding at the toe of the slope during every high water. They were a constant sediment source; there was no cover being provided and no vegetation could develop.

Treatment - Tailings were pulled back with a D-7 dozer. Objective was to reduce the slope and height of the tailings. Treated areas were seeded and fertilized after shaping.

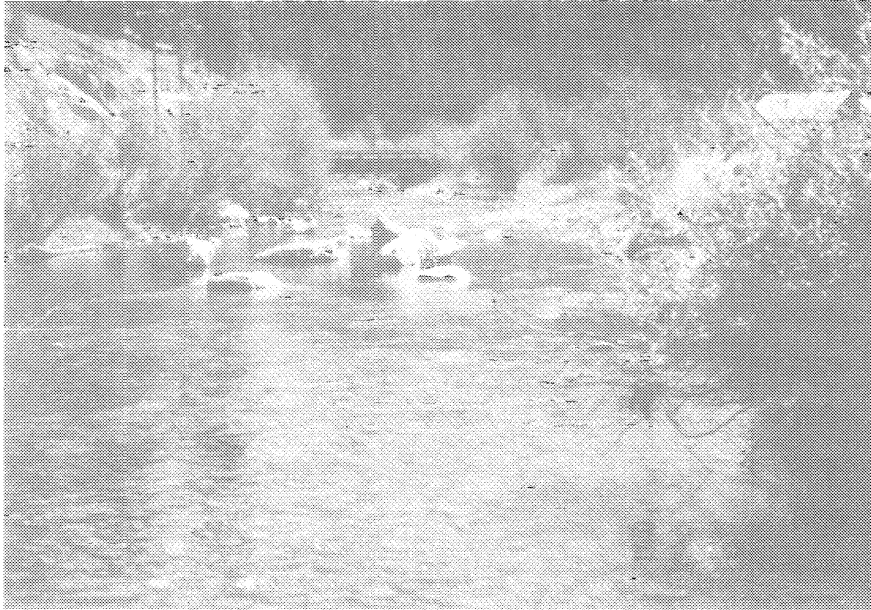
## EXAMPLE 1    RED RIVER

Description - This is a relatively shallow, open stream reach with no cover. There appeared to be no holding sites for either young or adult fish.

Treatment - Boulders were hauled in and placed, using a crane.

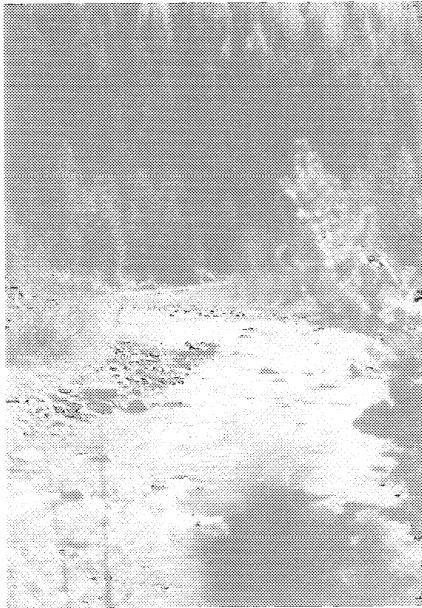
## EXAMPLE 1 - CROOKED RIVER

Description - Sites selected for installation of log weirs were long reaches of shallow runs and riffles unbroken by pools or deep runs.

Treatment - The general sequence of activities used when installing log weirs was similar to that reported in other areas and will not be detailed here. Basically the weirs consist of trees placed perpendicular to the stream flow and anchored 10' into each bank. A 6' wide layer of 2" x 2" wire mesh covered with filter cloth was placed on the upstream side and buried below streambed level approximately 1 foot. A pool was then excavated on the downstream site of each weir.

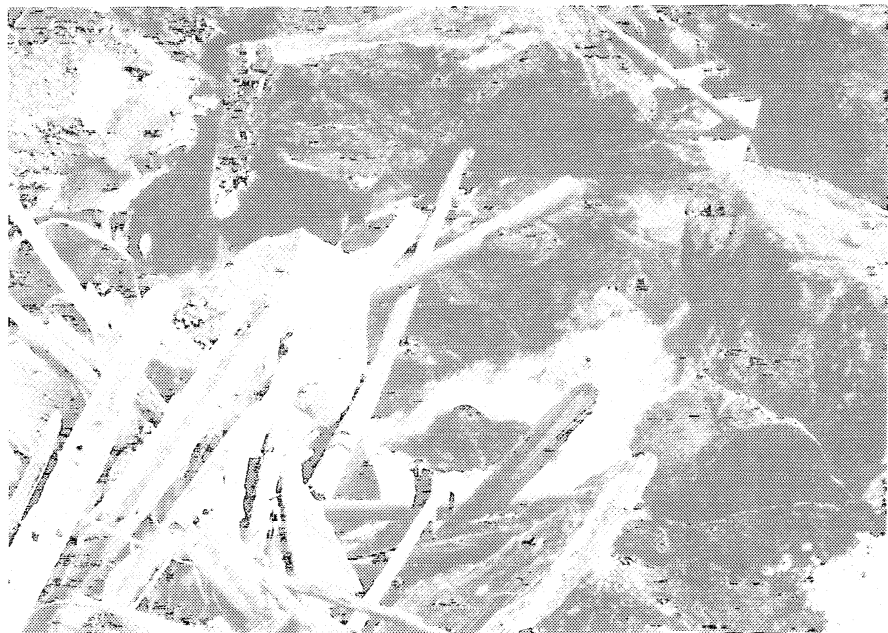
Photo 1-15 Barrier No. 2

After second blast. Note change in configuration of falls. Water here enters from right to first jumping pool above main pool below all falls. Water exits to left. Right bank falls has ceased to flow.

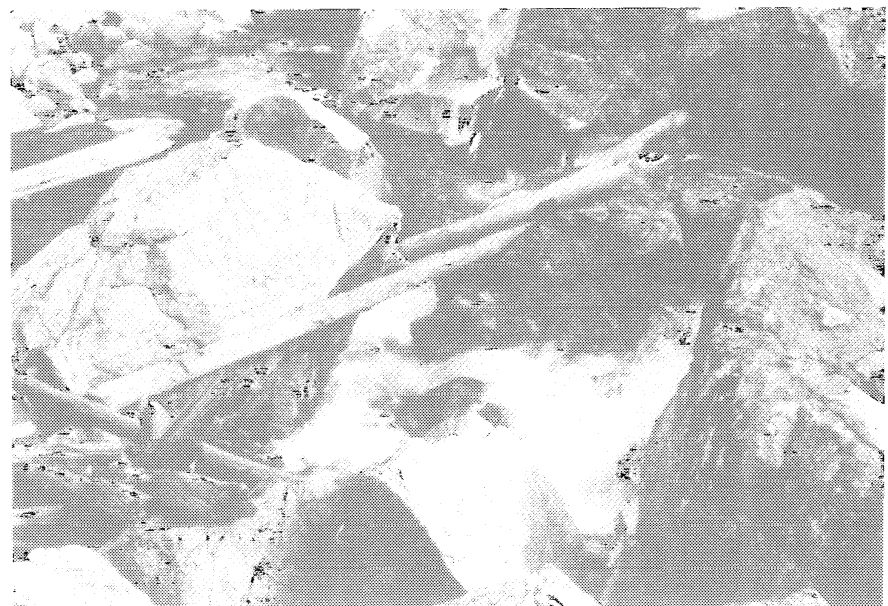
Photo 1-16 Barrier No. 2

Shows exit from first jumping pool above main falls.

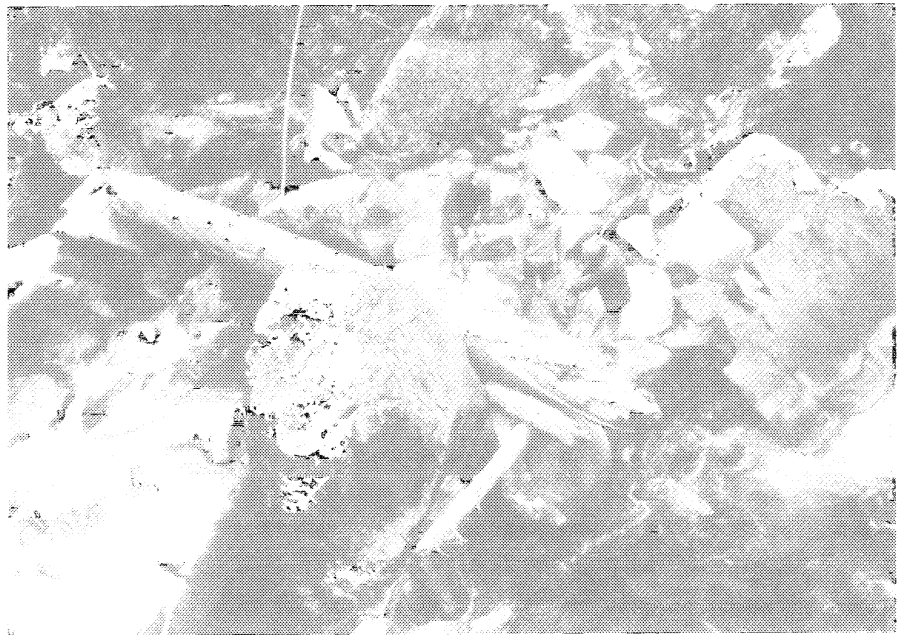
Photo 1-22 Barrier No. 3

Drilling in bypass area on right bank. Main flow of stream exits photo at lower left center.

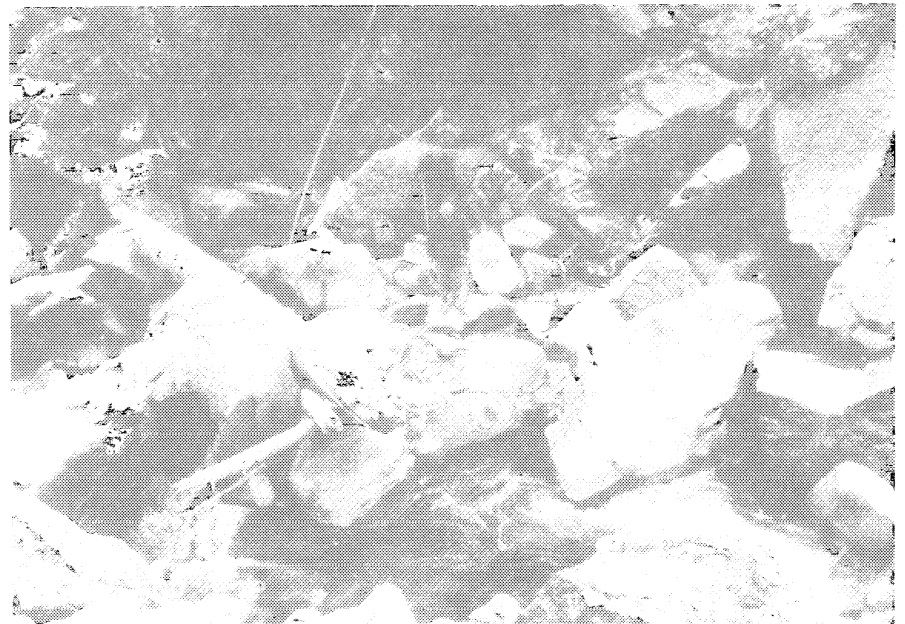
Photo 1-25 Barrier No. 3

Loading holes in bypass area on right bank.

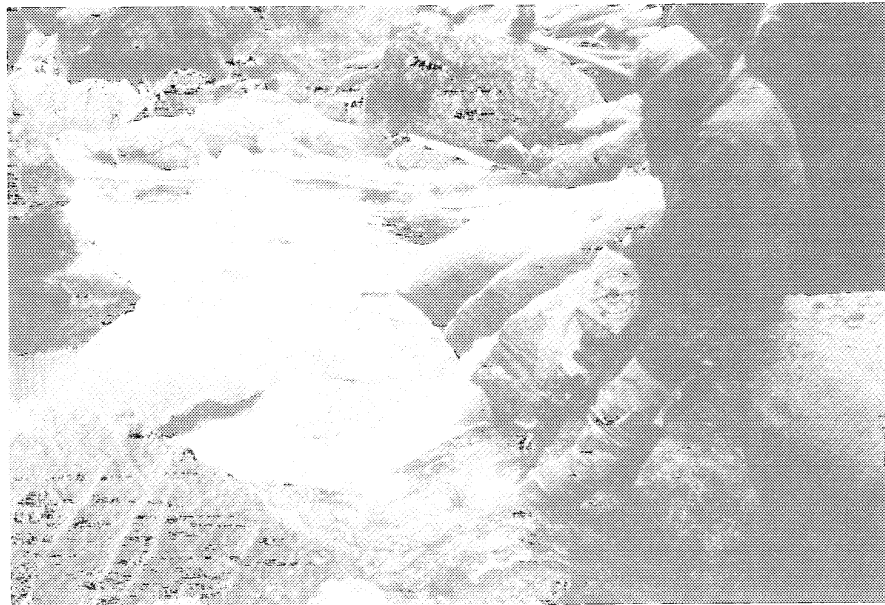
Photo 1-28 Barrier No. 3

Drilling at top of falls to provide pool for fish jumping main falls on left bank.

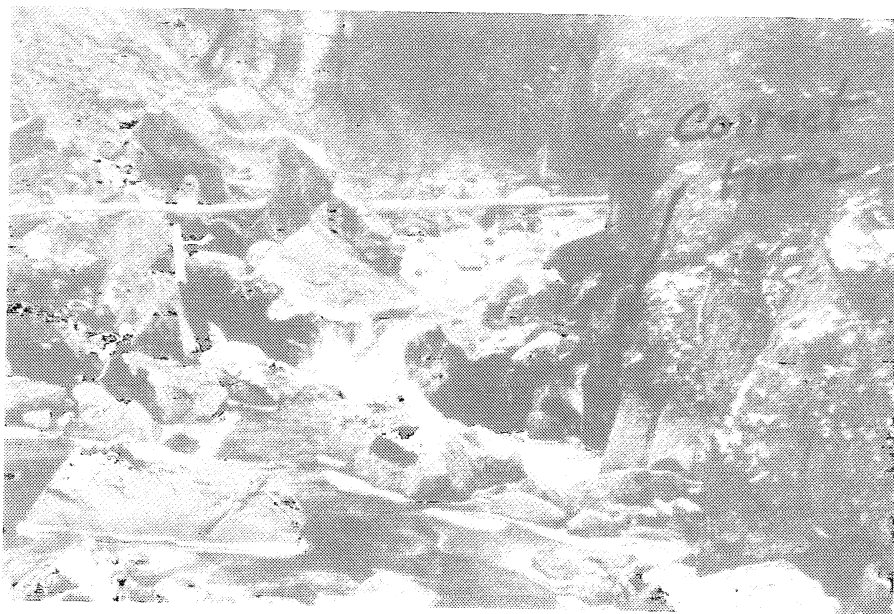
Photo 1-17 Barrier No. 4

This barrier, as was pointed out from a distance during the preliminary walk-through, was determined not to be a barrier at the flow observed and is probably not a migration barrier at any flow when considered with the entire cataract area. The location of this barrier was just below the confluence with Trout Creek. Grant Christensen agreed with this assessment. There is a distinct possibility that whatever rock or rocks that had constituted the barrier during the early investigations had moved so that the barrier no longer existed. Correction in this 40% cataract would be difficult at best. The entire cataract consists of large boulders, and they appear to be well keyed in the riverbed matrix.

General view of barrier which was not corrected. Gradient from base of falls to next upstream pool area is  $36\% \pm$ . Correction here should be on left bank where marked.

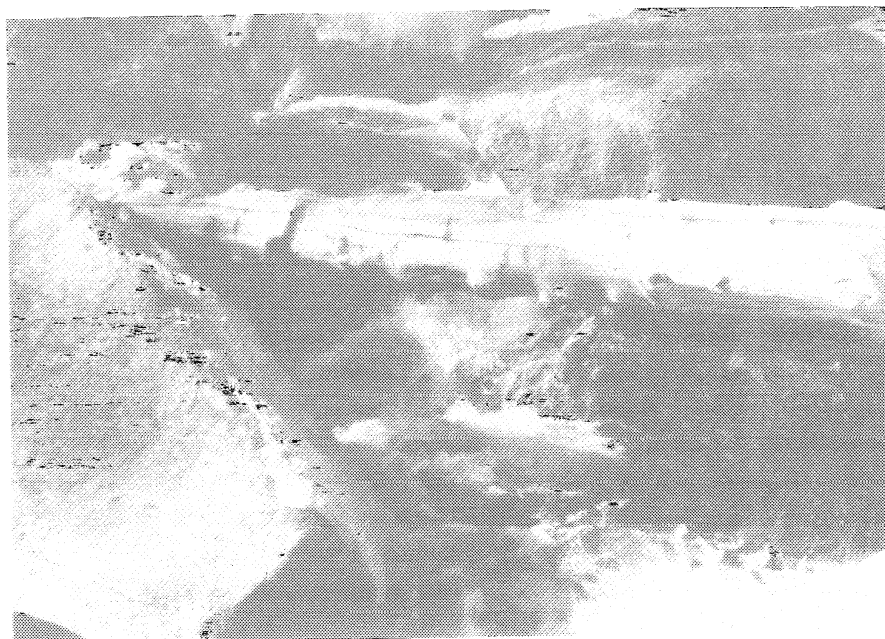
Photo 2-6 Barrier No. 1

Results of first shot showing water in new channel. Existing pool in lower foreground.

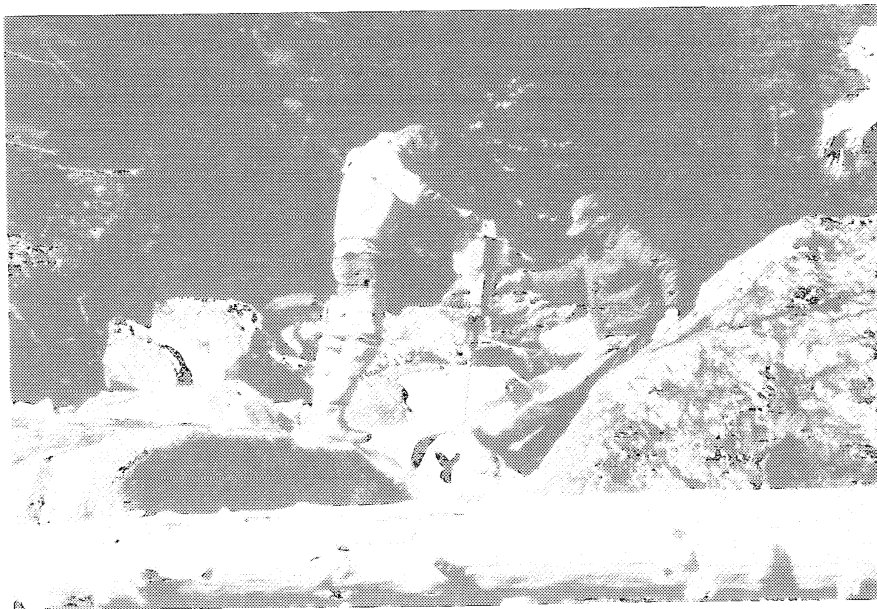
Photo 2-2 Barrier No. 1

Rock marked "Y" being drilled to provide auxiliary water to attraction flow created by first blast in Photo 2-6.

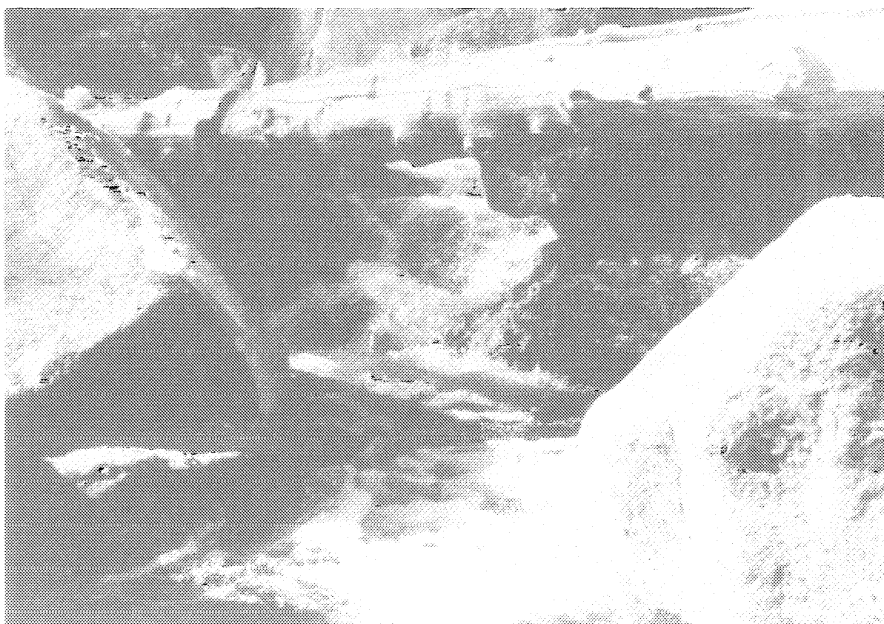
Photo 2-8 Barrier No. 1

View of new fish bypass route with resting/jumping pool in center foreground. Loose rock here will move out with high water.
